Manhole Inspection Summary

Manhole # S33OO1014MH

Insp Date: **11/5/08 12:06 PM**

Location Address: **MILLBROOKE RD**

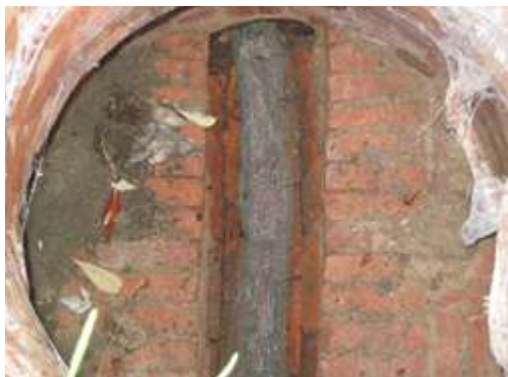
Top View

Corroded steps. Evidence of surcharge - Bench debris.

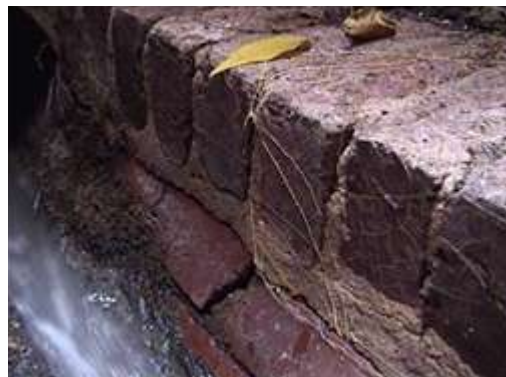
Defect

Channel deterioration and root intrusion.

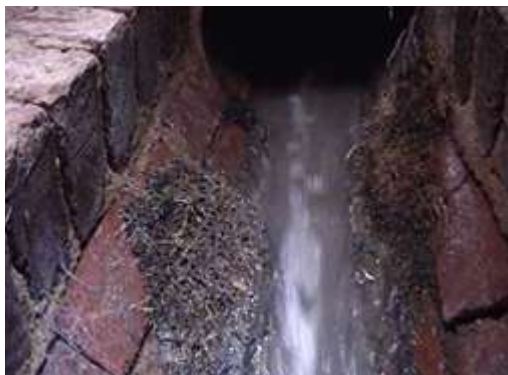
Defect

Channel deterioration and root intrusion.

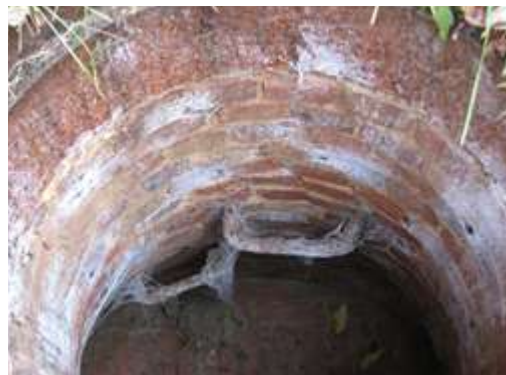
Defect

Adjustment infiltration. Corbel deterioration and infiltration. Barrel infiltration.

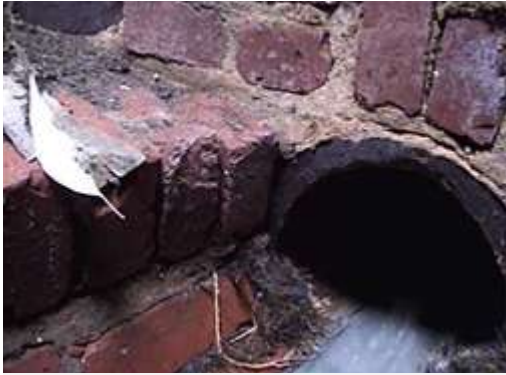
Defect

Bench deterioration.

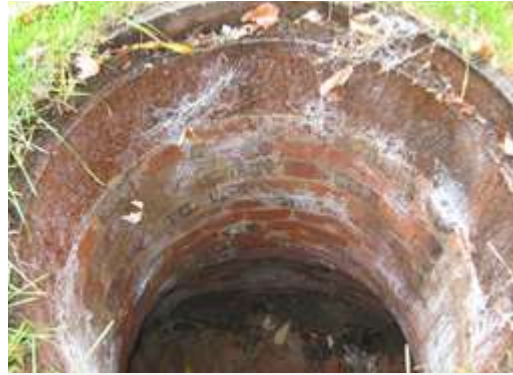
Defect

Adjustment, Corbel and Barrel infiltration.

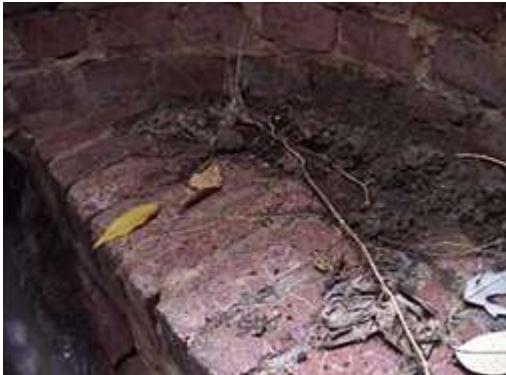
Defect

Barrel root intrusion.

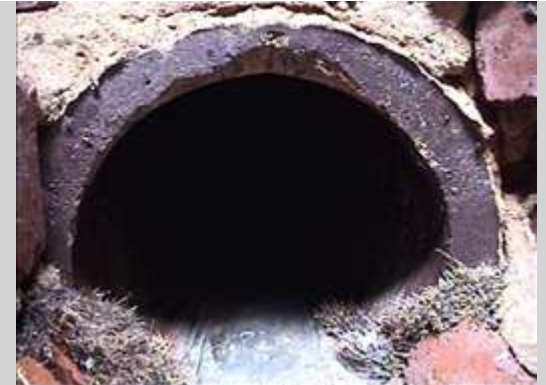
8 in. Circular Gravity Sewer Pipe Out @ 12 O'Clock

Infiltration: **None** Pipe Seal Cond: **Roots**

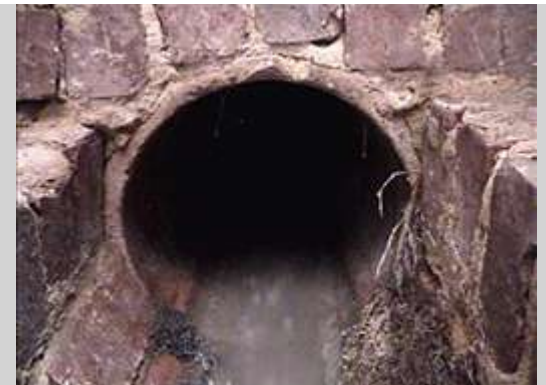
8 in. Circular Gravity Sewer Pipe In @ 6 O'Clock

Channel root intrusion.

Infiltration: **Evidence** Pipe Seal Cond: **Roots**
